Flexural behaviour of pre-damaged RC beams retrofitted using CFRP laminates

ADVANCES IN CIVIL AND ARCHITECTURAL ENGINEERING (ISSN 2975-3848)

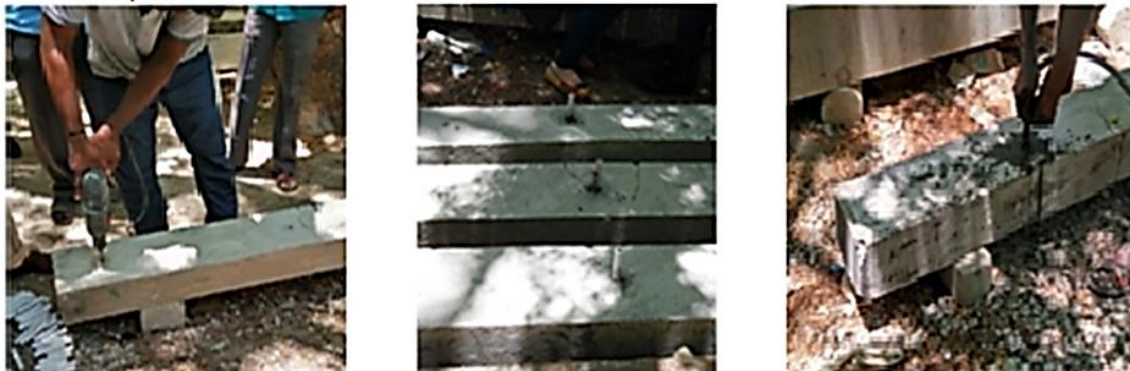
Among the six RC beams tested, four beams were subjected to failure, while two beams were subjected to 90 % of the ultimate load in the loading frame. All five pre-damaged beams were cleaned, and grouting was performed on the cracked regions. PVC pipes were inserted into drilled holes-20 mm in diameter, up to a depth of 50 mm to inject the chemicals, which included Cera Poly Clay mortar (a microfibre-enriched cementitious repair mortar) and Cera Poly Crack

Filler (a non-shrink, polymer-modified cementitious material reinforced with micro fibers), which were combined with water to form a paste and applied over the cracked regions. Thereafter, styrene-butadiene rubber latex, mixed with cement and water, was applied onto the surface of the pre-damaged beams. Figure 3. illustrates the grouting process of pre-damaged beams. Subsequently, a thixotropic adhesive base (Nitowrap 40) and its hardener were mixed and applied to the prepared and cleaned surfaces. This ensured effective pasting or bonding of the CFRP laminate (Figure 4). Nitowrap 30 epoxy primer and Nitowrap 410 saturant were used for bonding the CFRP fabrics onto the laminates.

Figure 3. Grouting process for the pre-damaged beams

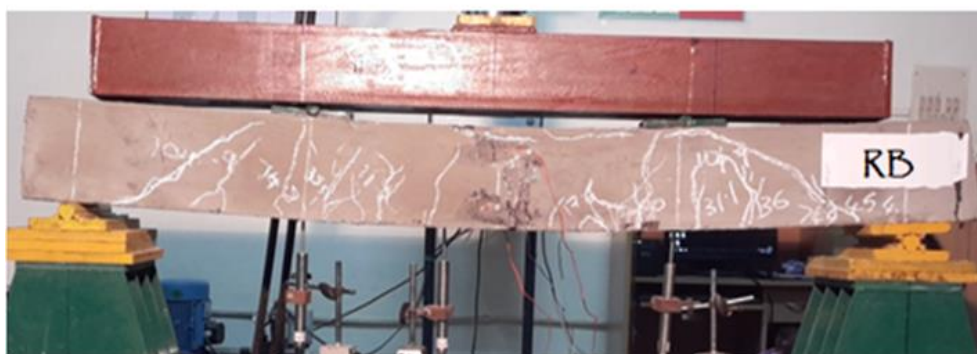
Figure 8. Crack pattern of the grouted pre-damaged beam
