Field investigations of deformations in soft surrounding rocks of roadway with roof-bolting support by auger mining of thin coal seams

Rudarsko-geološko-naftni zbornik
(The Mining-Geology-Petroleum Engineering Bulletin)
UDC: 622.1:622.3:622.8
DOI: 10.17794/rgn.2022.2.3

Original scientific paper

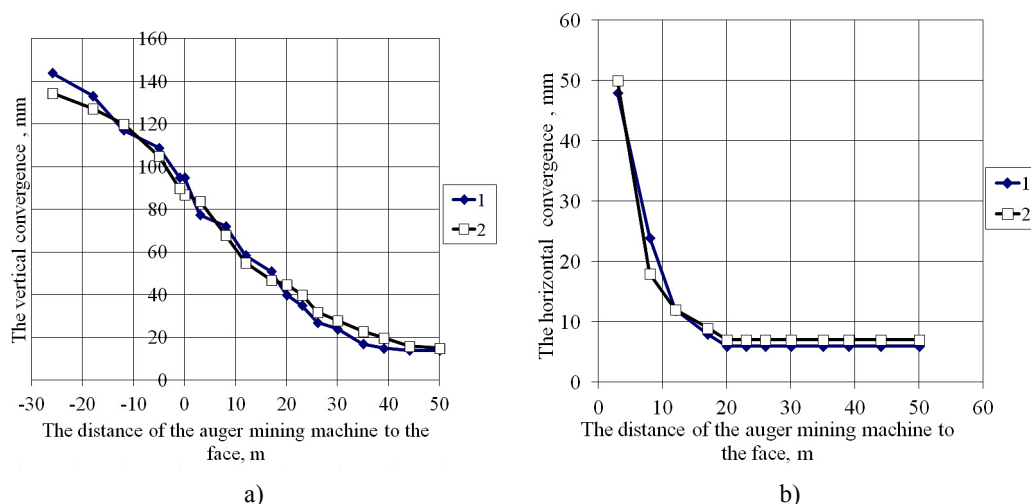
Figure 10. Vertical (a) and horizontal (b) convergence of the conveyor roadway mine depending on the distance of the auger mining machine to the face

1, 2 - contour monitoring station KS # 1 and KS # 2, respectively

carried out using an auger mining machine at one side, according to which the asymmetry of the vertical deformations in the roadway was observed. The influence zone of the face on the vertical convergence was about 30m, and the horizontal one was about 15 m (see **Figure 10**). During the face extraction, the side benchmarks were lost, therefore, the measurements of the horizontal deformations were observed only at the area before the face (see **Figure 10b**). The auger mining rate was 32 metres per month along the roadway.

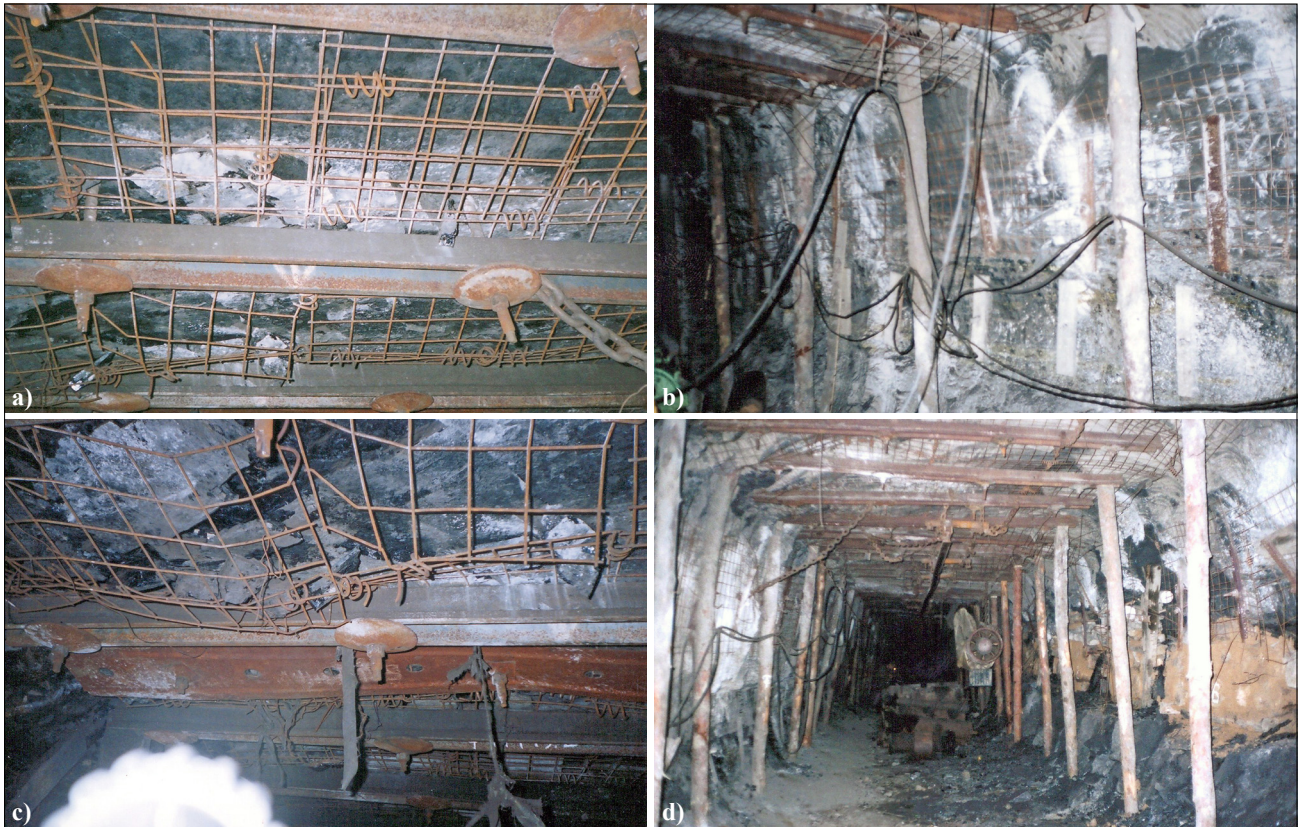
Figure 11. Condition of the rocks of the roof (a, c) and sides (b, d) of the conveyor roadway of the northern main longwall of seam k_8^u at a distance of 25-30 m before the face (a, b) and 25 m after the face (c, d)

Foot deformation was not observed with reference to the neutral axis. The rocks of the roof actively stratified with cakes which were 5-8 cm thick in the influence zone of the face. The destroyed rocks were supported with mesh (see **Figure 11a**). Before auger-mining the face, the extrusion of coal and its destruction at the part of uprising of the seam was observed. Therefore, some additional horizontal bolts were installed in the sides of the roadway (see **Figure 11b**). When removing the side bolts before coal extracting, some rock falls from the sides were observed.

A general view of the condition of the rocks in the roadway at a distance of 25-30 m before the face is shown in **Figure 11 a, b**, and at a distance of 25 m behind the face it is shown in **Figure 11 c, d**.

In the zone of influence of the auger mining machine, the rocks actively stratify with cakes which are 5-8 cm thick. Before auger mining the face, the squeezing of coal and its destruction from the uprising side of the seam was observed. After the coal extraction, the stratification of the roof is activated, which leads to single cases of deformation of the mesh, rock falls and the formation of a dome.

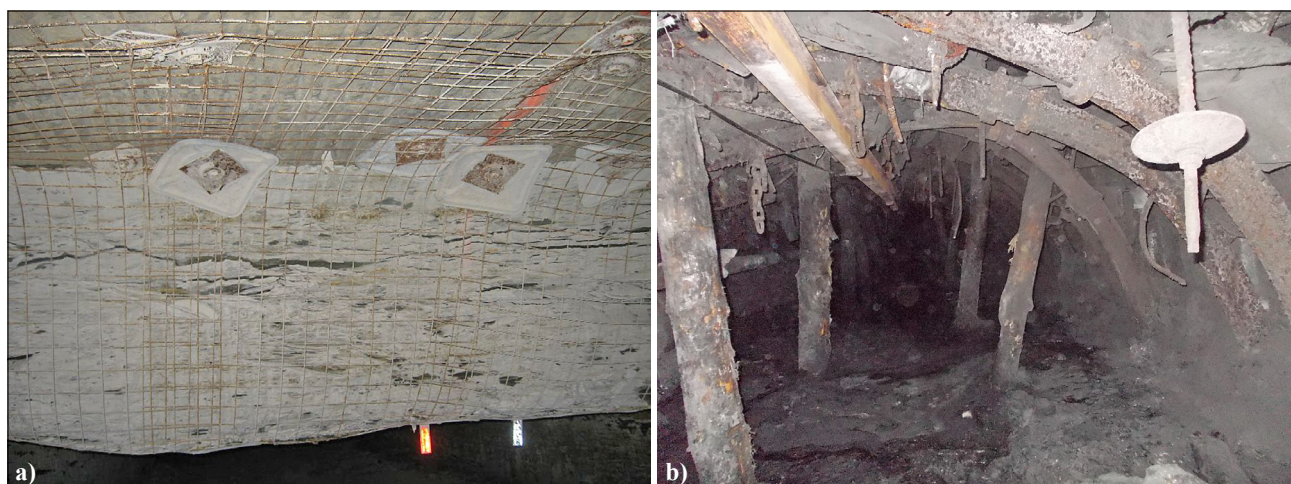
Figure 12. Bed separation in weak shale fixed by rock bolts
 a) Collections Illinois, USA (Molinda and Mark, 2010)
 (b) Management Board of the «Pokrowskoje» Mine, Ukraine (authors' photo)

While the results of the observations at the contour stations do not essentially differ from the studies of other authors (Heritage, 2019, Niedbalski et al., 2013, Xie et al., 2018, Malkowski et al., 2016, Jena et al., 2016, Singh et al., 2004), the telltales have shown some new results. In particular, it was found that the stratification of contour rocks differs in time from the generally accepted one. If most authors (Heritage, 2019, Niedbalski et al., 2013) note that stratification begins on the roadway contour and gradually develops into the depths of the rocks, then the conducted studies determined that for the roadways with bolts, the destruction of rocks can occur outside the zone supported with anchors before the rocks inside the bolt zone get cracked. The resin bolts retain stratification within the length of the bolt. However, some more defects occur at depth and they cause more stratification. The occurrence of these defects contributes to the displacement of rocks within the confined zone as a single block. This can lead to a rock fall with anchors from the mine array. Such cases are known in mining (see Figure 12).
